FIELD STUDY AND DOCUMENTATION OF THE 1930 SALMAS (SHAHPUR - AZARBAIDJAN) EARTHQUAKE

M. BERBERIAN and J.S. TCHALENKO

GEOLOGICAL SURVEY OF IRAN ; IMPERIAL COLLEGE, LONDON

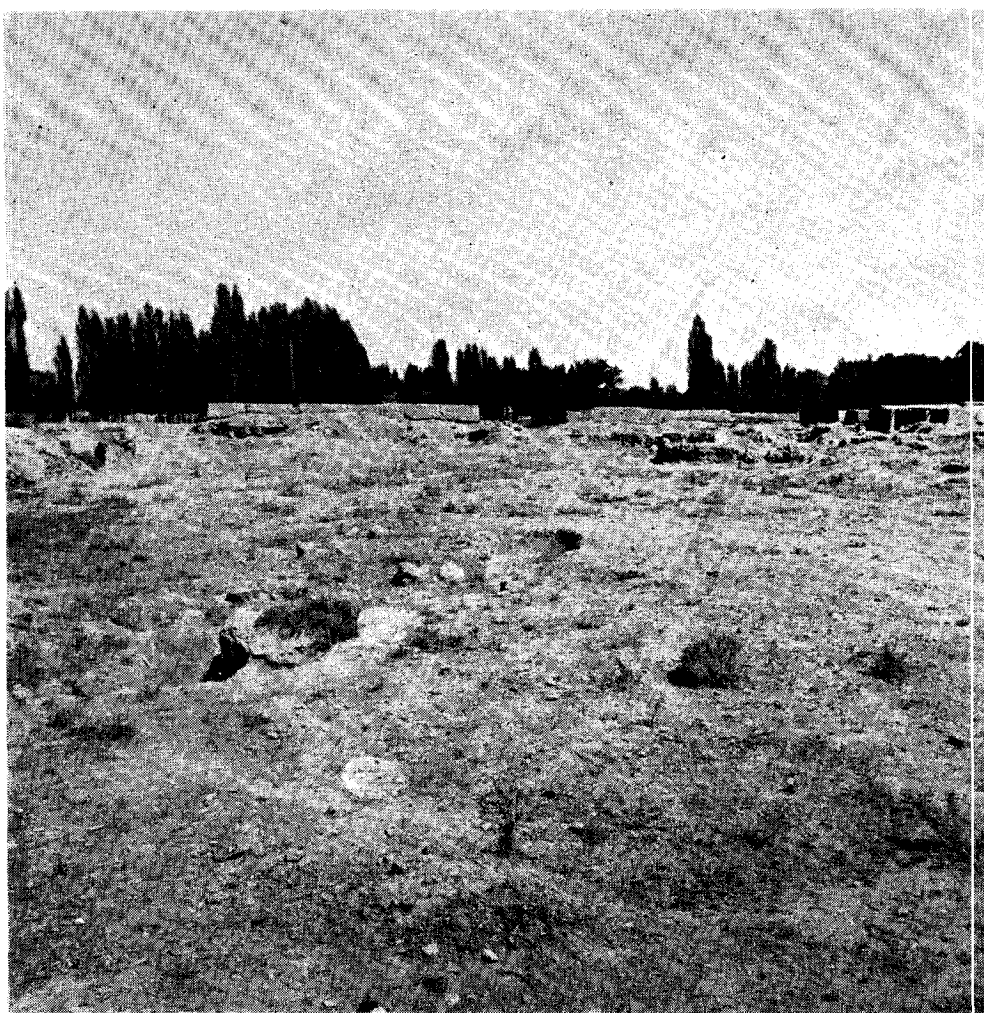
Fig. 5. Site of Khosrova. The destroyed village photographed in 1973.

Shahr, Payajuk and Zaviehjuk (Fig. 3). Here all the houses were levelled to the ground (Fig. 5). The most intense destruction probably occurred near the Kohne Shahr apex where all but one of the 20 churches in the villages of Kohne Shahr, Savra, Khosrova, Uleh, Malham, Gulizan and Patehvir were destroyed. The exception was Mar Givargis in Khosrova, a large, masonry structure with walls built in the traditional style, i.e. about 1.25m thick, with an outer layer of hewn stone, an inner layer of rough stone and good cement mortar. The 4 inner pillars and the vaulted roof collapsed, but most of the walls, excepting the corners of the building, remained standing (Fig. 6). In Malham, which, with Saramerik, was the only Christian village where most of the inhabitants

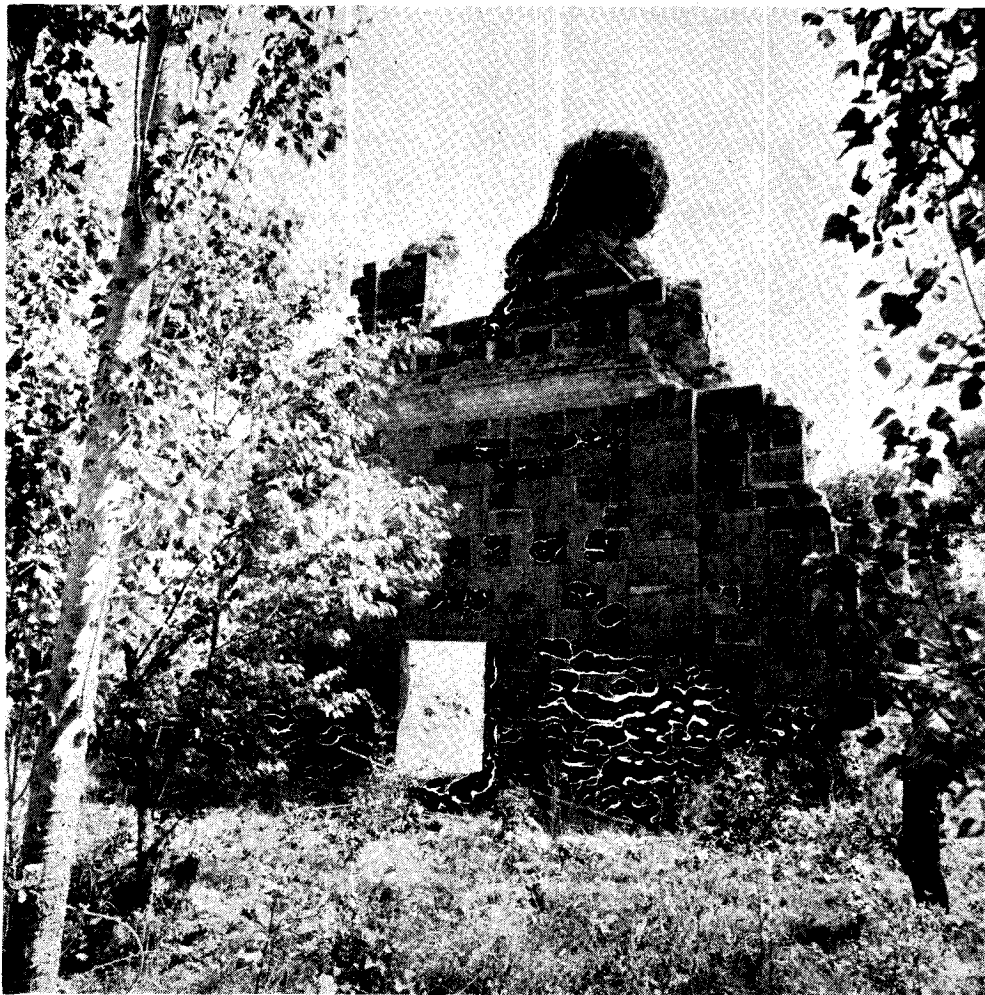
Fig. 6. S. Givargis (Khosrova). The only one of 20 churches which remained standing in the region of maximum destruction. Western facade.

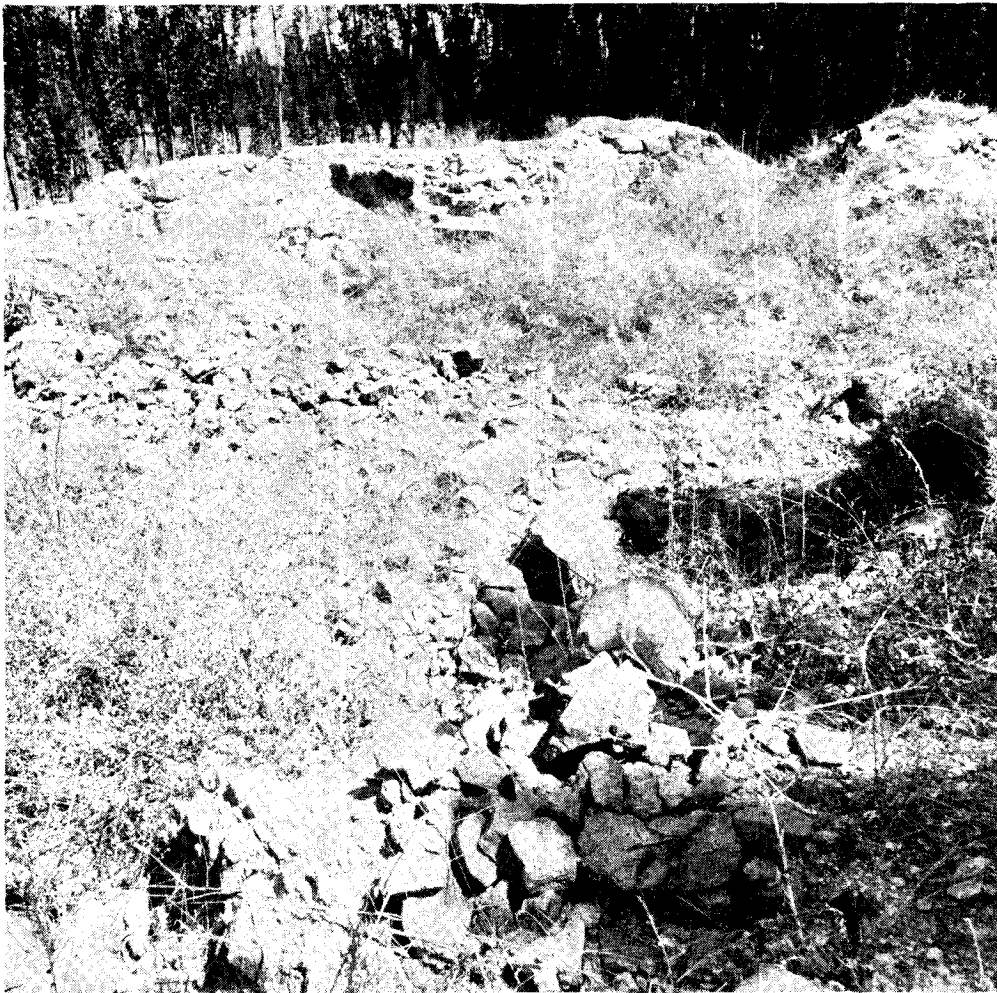
Fig. 8. S.Hovanes (Savra). The church destroyed by the earthquake. Looking northeast.

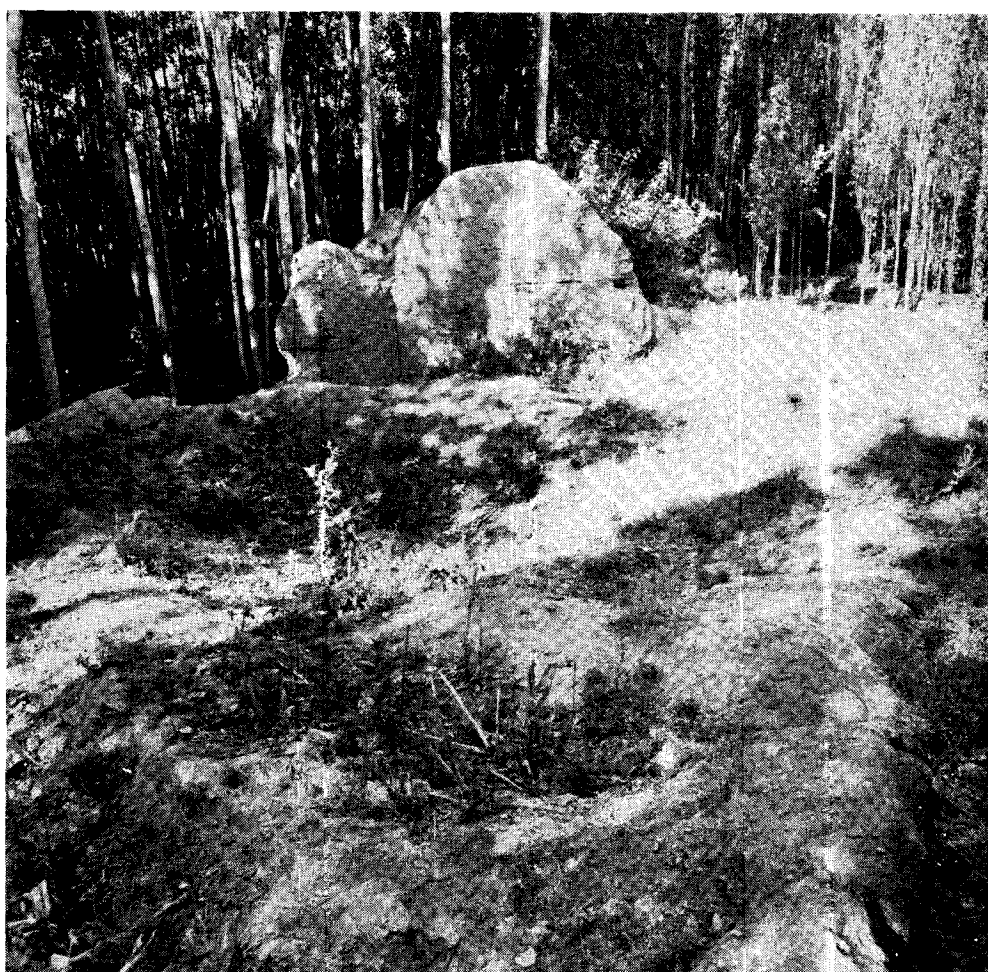
Fig. 10. S. Sarkis (Uleh). The church destroyed by the earthquake

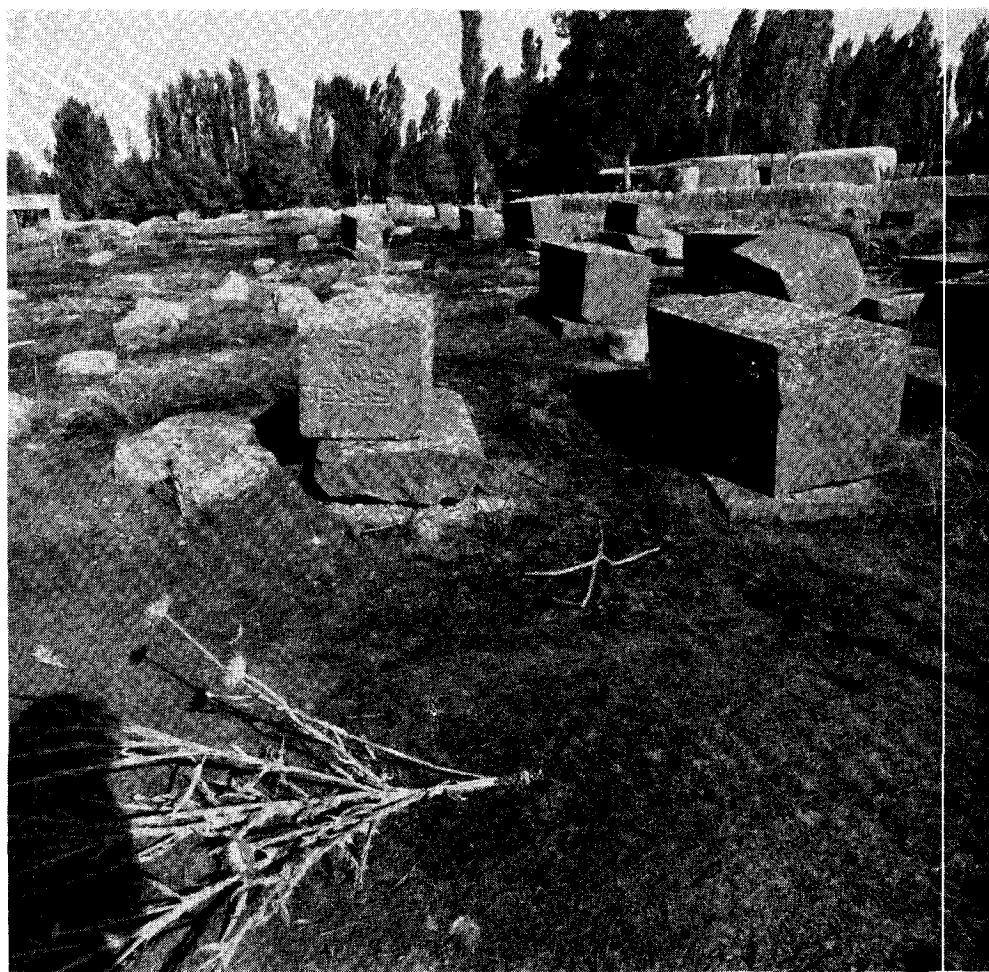
Fig. 15. Tombstones in Khosrova cemetery. Examples of translation (left) and rotation (right) of the upper block with respect to the base. Note some tilted tombstones in the background.

face. Examples of tombstone movement are given in figure 15 and their locations are shown in figure 17. A number of tombstones (not included in the above account) were also tilted sideways, generally to the N or the S and often without any visible displacement of the block on its slab, probably as a result of foundation failure under the slab. The Khosrova cemetery is located about 4km from the earthquake fault, the latter being oriented NW-SE and of right-lateral displacement with the NE side downthrown.

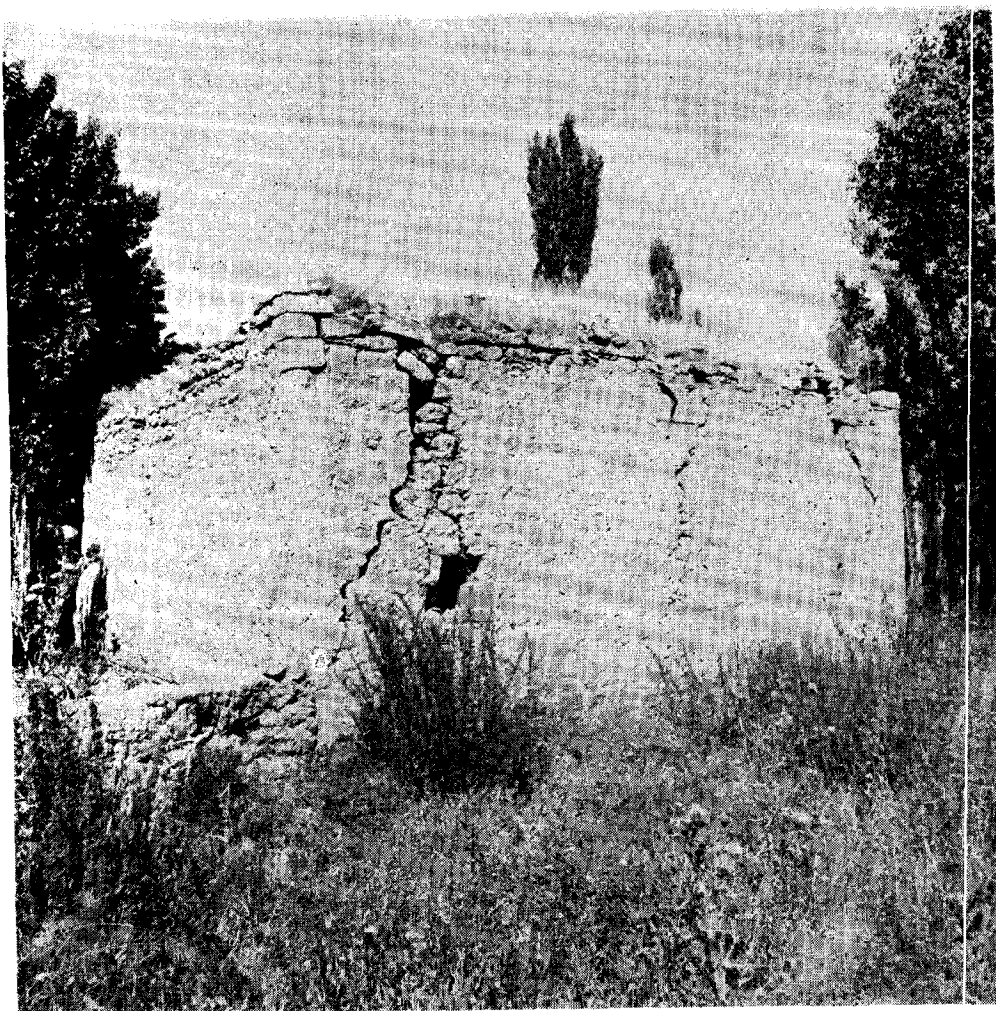
Fig. 21. S. Asdvadzadzin (Sarnaq). Eastern wall of the church, which partly survived the earthquake.

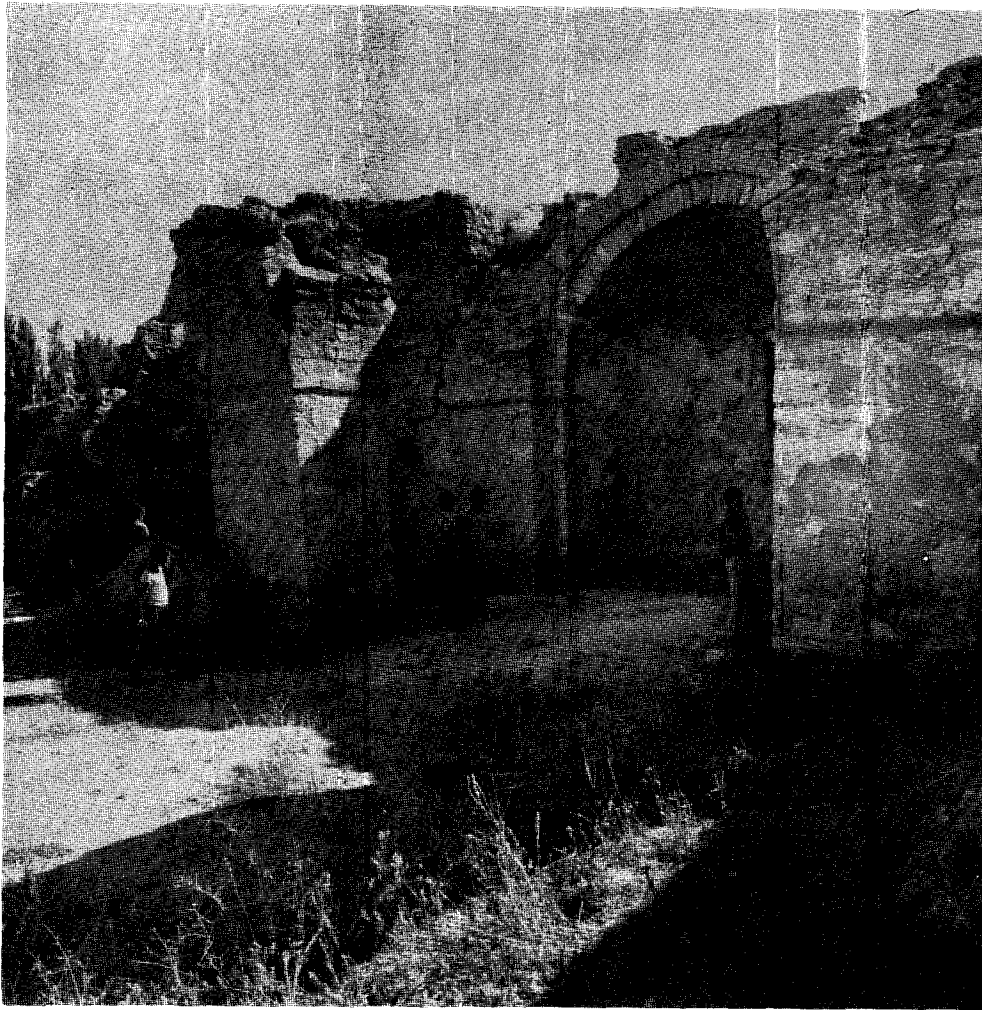
Fig. 22. S. Sarkis (Drishik). Eastern apse seen from interior of ruined church. The western facade and most of the northern wall were completely destroyed.

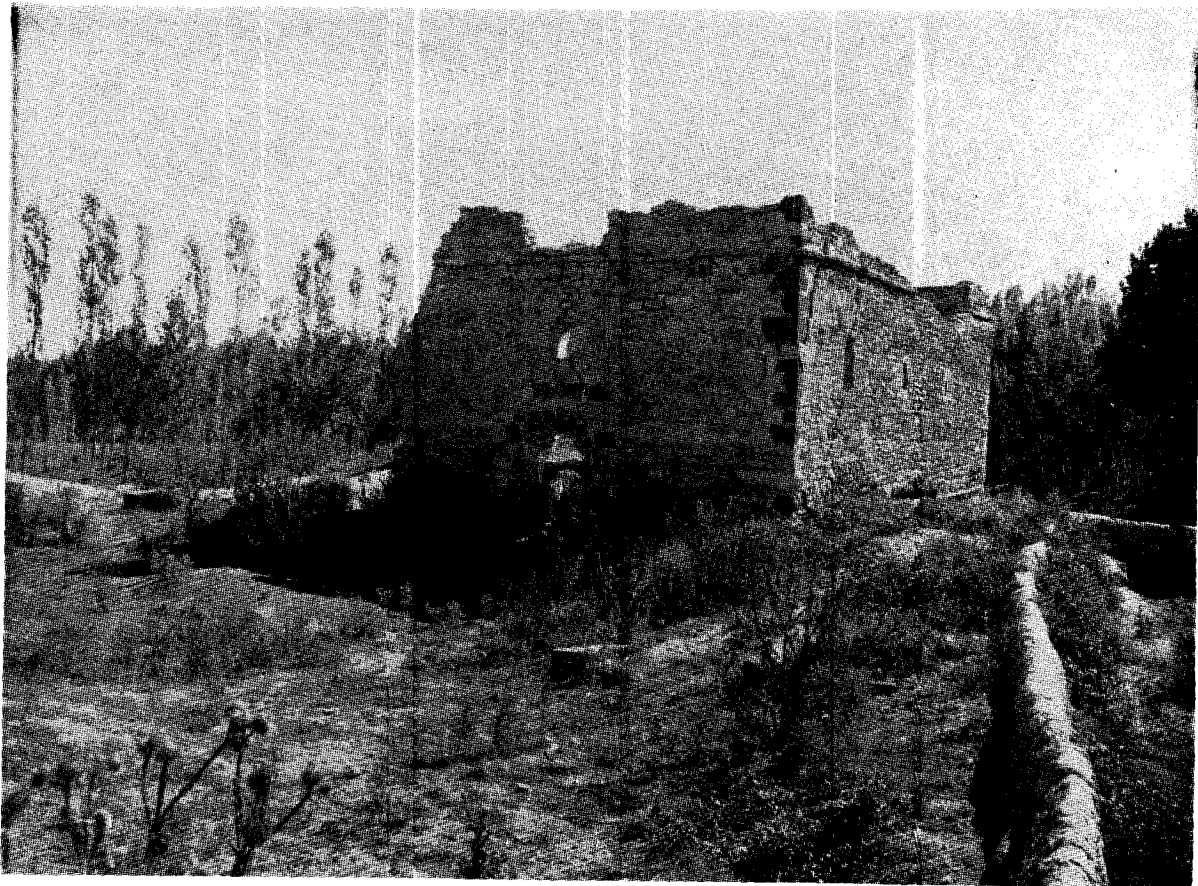
Fig. 26. S. Sarkis (Ghalasar). Western facade and southern wall. The northern wall collapsed to the north.

shaking was here probably less severe. In Ghalasar, the roof of S.Sarkis partly collapsed and the northern wall fell to the north, but the other walls survived at their full height (Fig. 26). This collapse towards the north, also observed for the small parapet wall surrounding the roof of the church, is exceptional, and may be compared to the dominant northward displacement of the tombstones in Khosrova and the northward shift of Zayia's car. The church of S. Asdvadzadzin in Akhtékhaneh survived, although it was fissured (Fig. 27); it is a 14th century construction with the traditional double wall (kiln-brick inside, rough masonry outside), and a roof with three kiln-brick domes. The northern and eastern walls were fissured, and the interior N-S arches developed

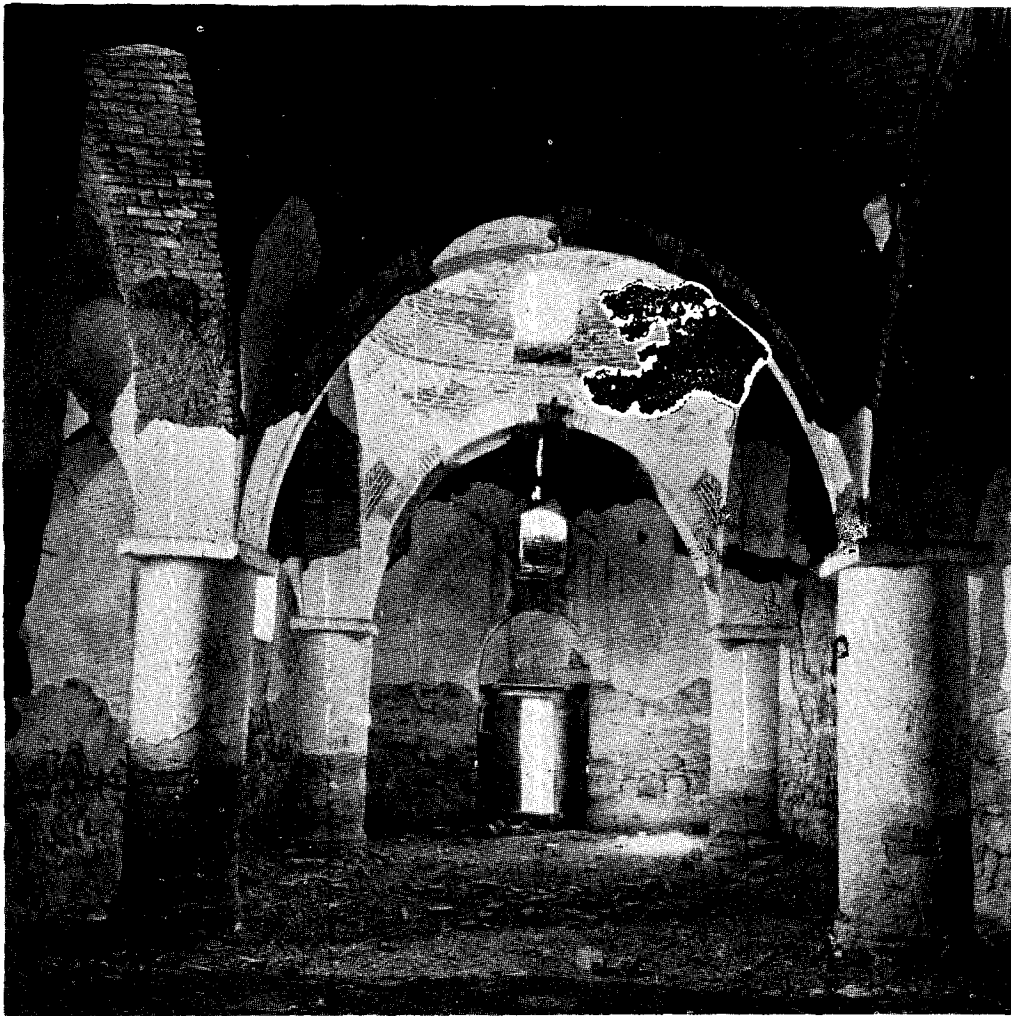
Fig. 28. S. Asdvadzadzin (Akhtekhaneh). The main interior damage was a central east-west fissure seen near the keystones. Looking west.

cracks near their keystone (Fig. 28). In the nearby village of Ghezolja, S. Hovanes also survived, though more damaged than S. Asdvadzadzin (Fig. 29). This church, provisionally dated 1007 A.D. from an inscription on the doorway, is a rough masonry construction with four pillars supporting a central dome. All four walls were fissured diagonally, and an important central crack crossed the whole roof from E to W.

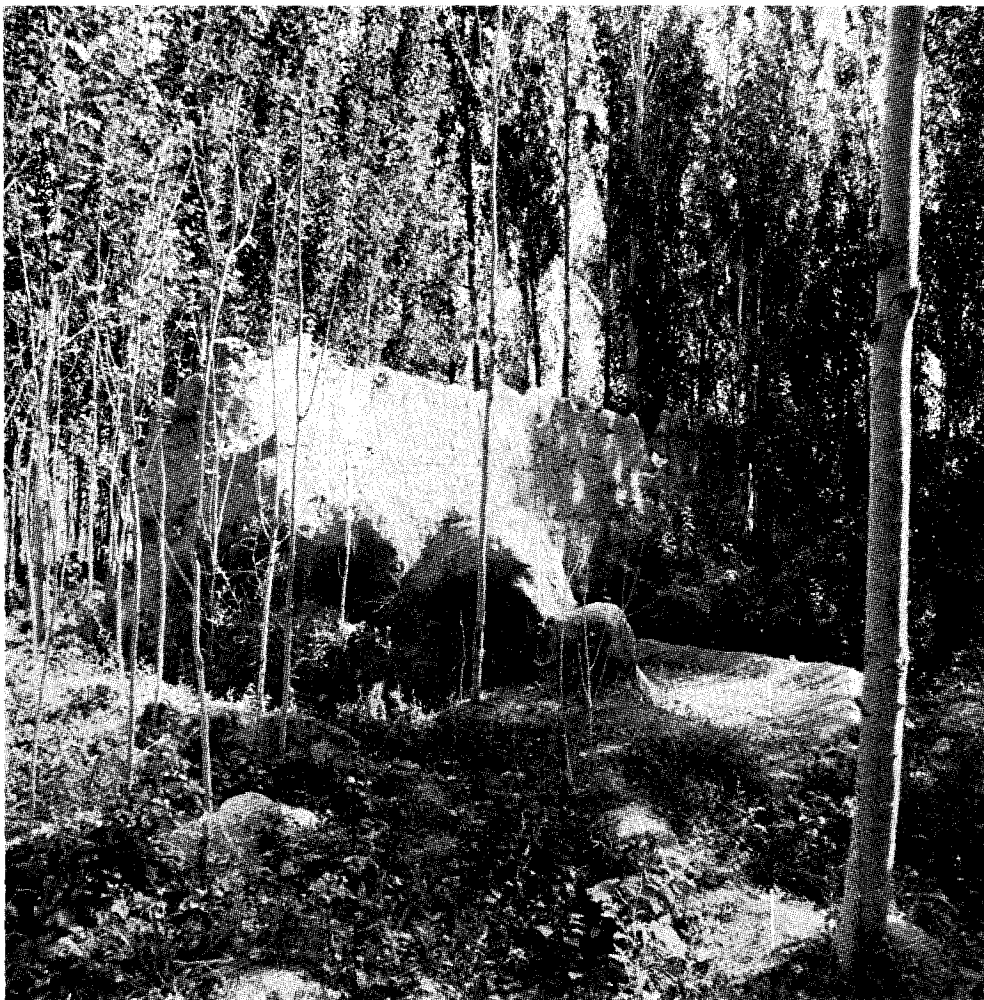
Fig. 32. S. Asdvadzadzin (Ayan). The northern wall of the adobe church is still standing. It was already in bad repair before the earthquake.

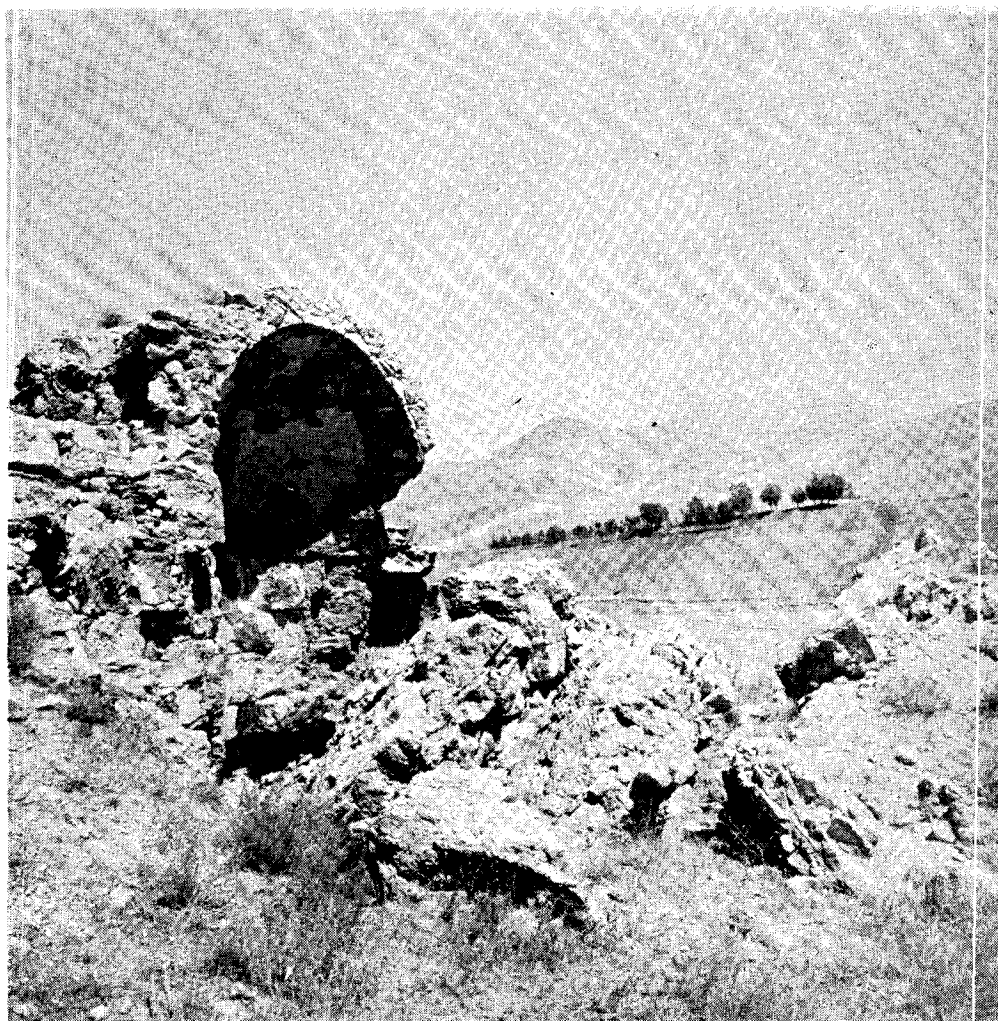
Fig. 35. S. Asdvadzadzin (Derik). Only the apse of the small chapel survived the earthquake.

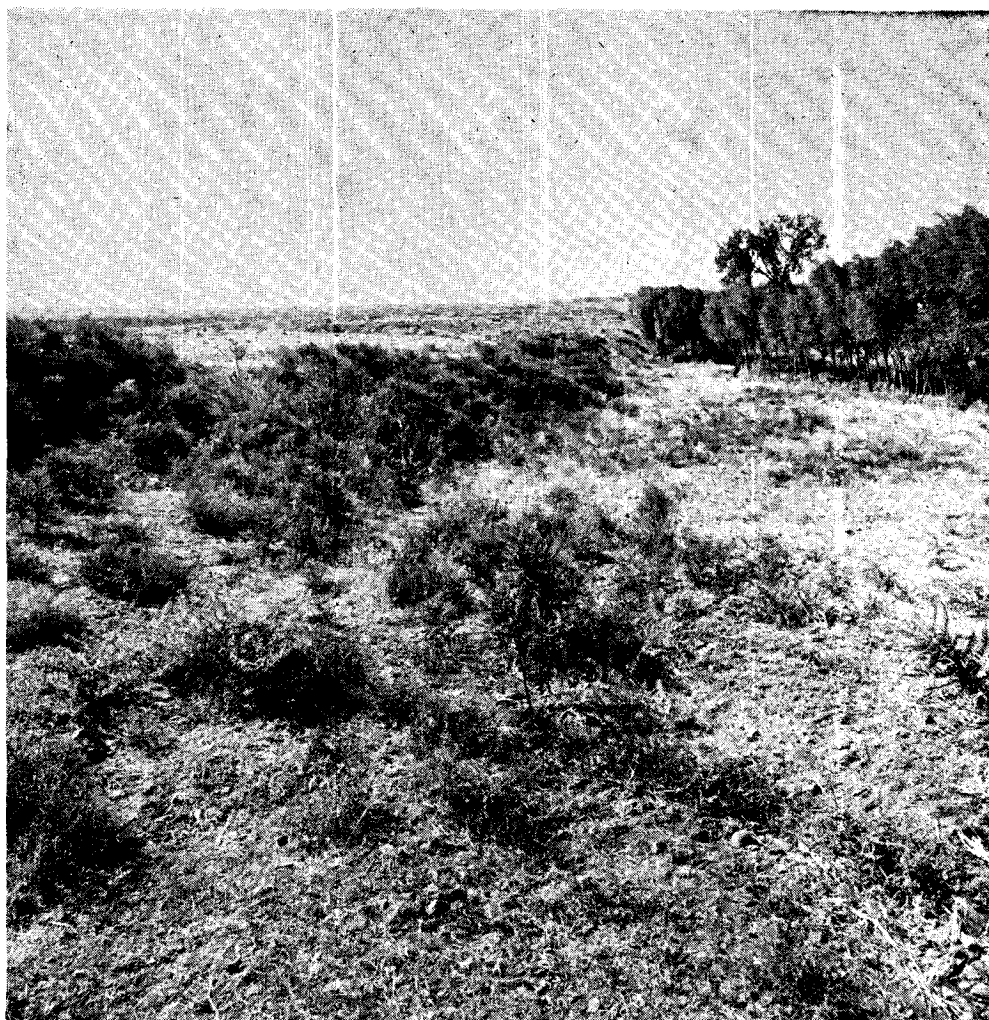
Fig. 44. Salmas Fault, Zaviehjuk segment. Eroded fault scarp west of Zaveihjuk. The vertical throw is here about 3m (NE, i. e. right side, down). Looking NW.

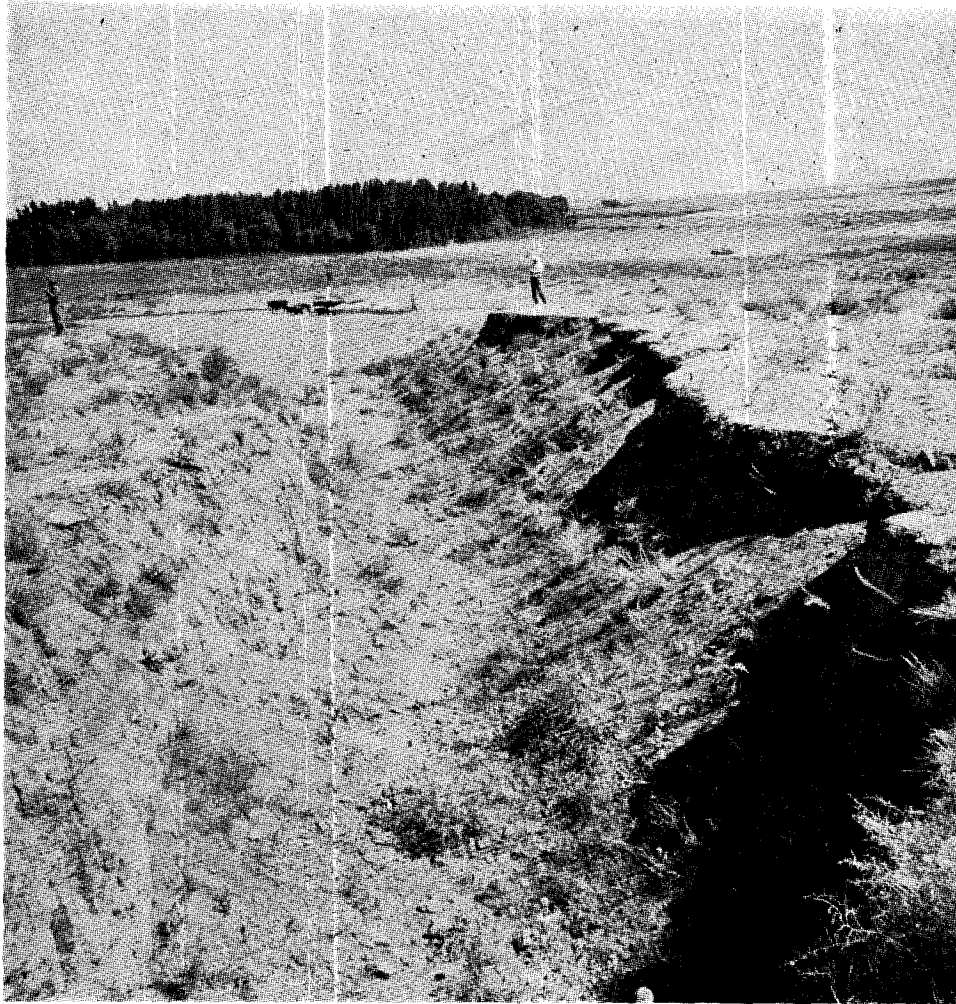
Fig. 46. Salmas Fault, Zaviehjuk segment. Fault scarp, here dissected by a post-earthquake erosion gully, is located between the two standing figures. Looking NE.

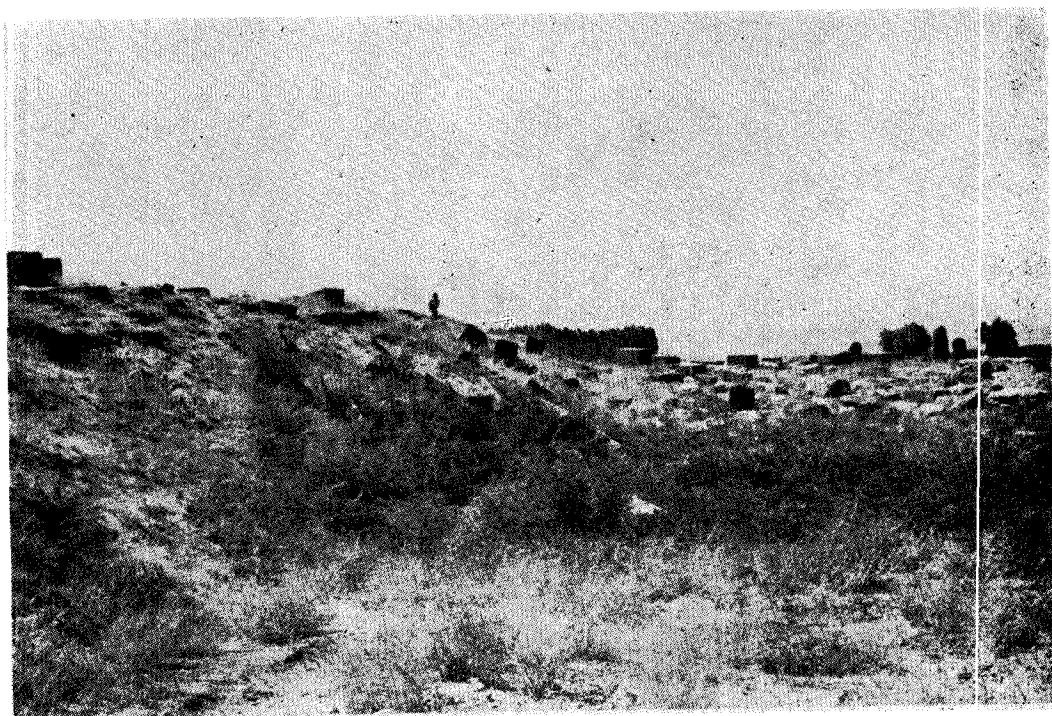
Fig. 47. Salmas Fault at Malham cemetery. Apparent throw is about 4m. Looking NW.

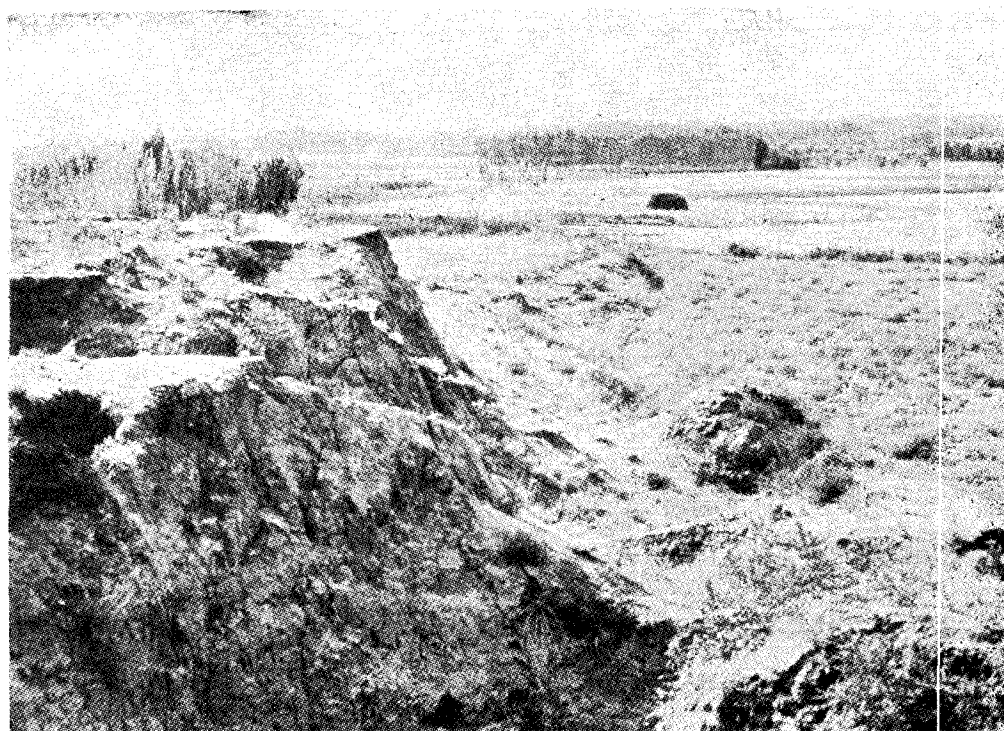
Fig. 48. Salmas Fault, Zaviehjuk segment. The earthquake fault scarp is here superimposed on a pre-existing topographical step, with a resulting apparent throw of about 6m. Between Malham and the Zola Chay, looking NW.

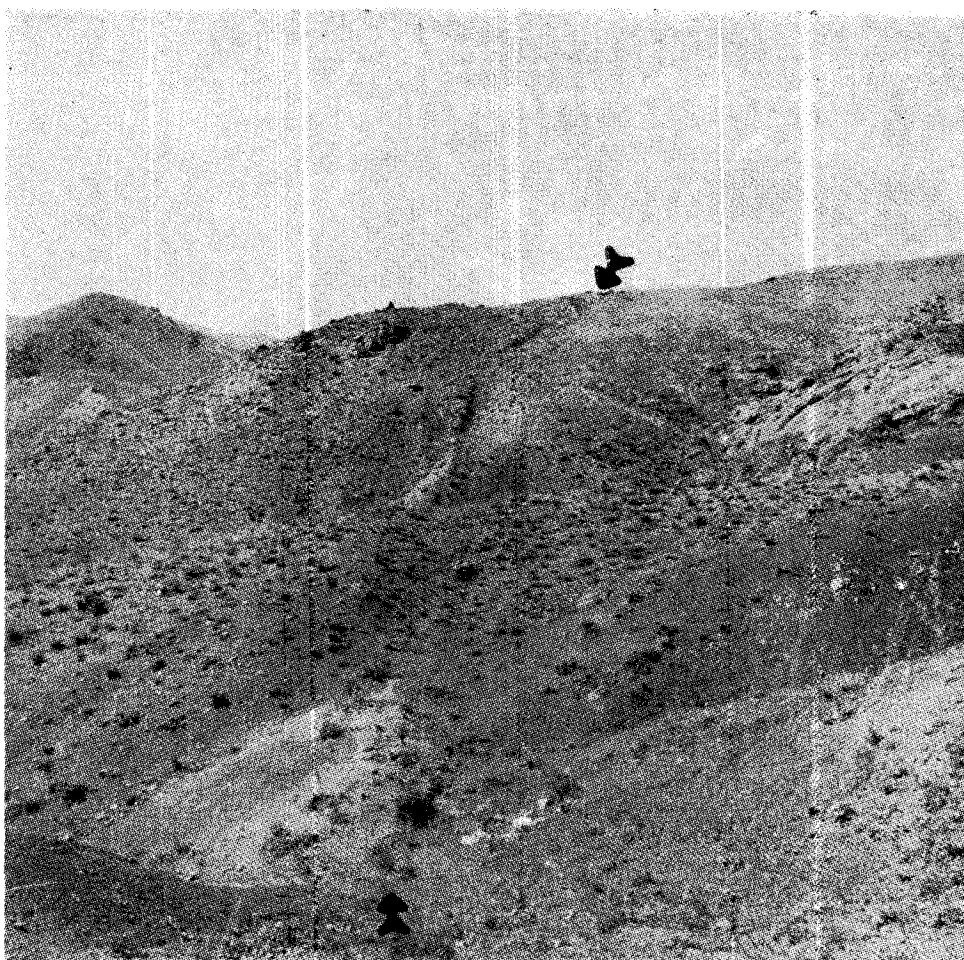
Fig. 51. Derik Fault. Section north of the old village. Vertical displacement is about 1m (NW, i. e. right side, down). Looking SW.

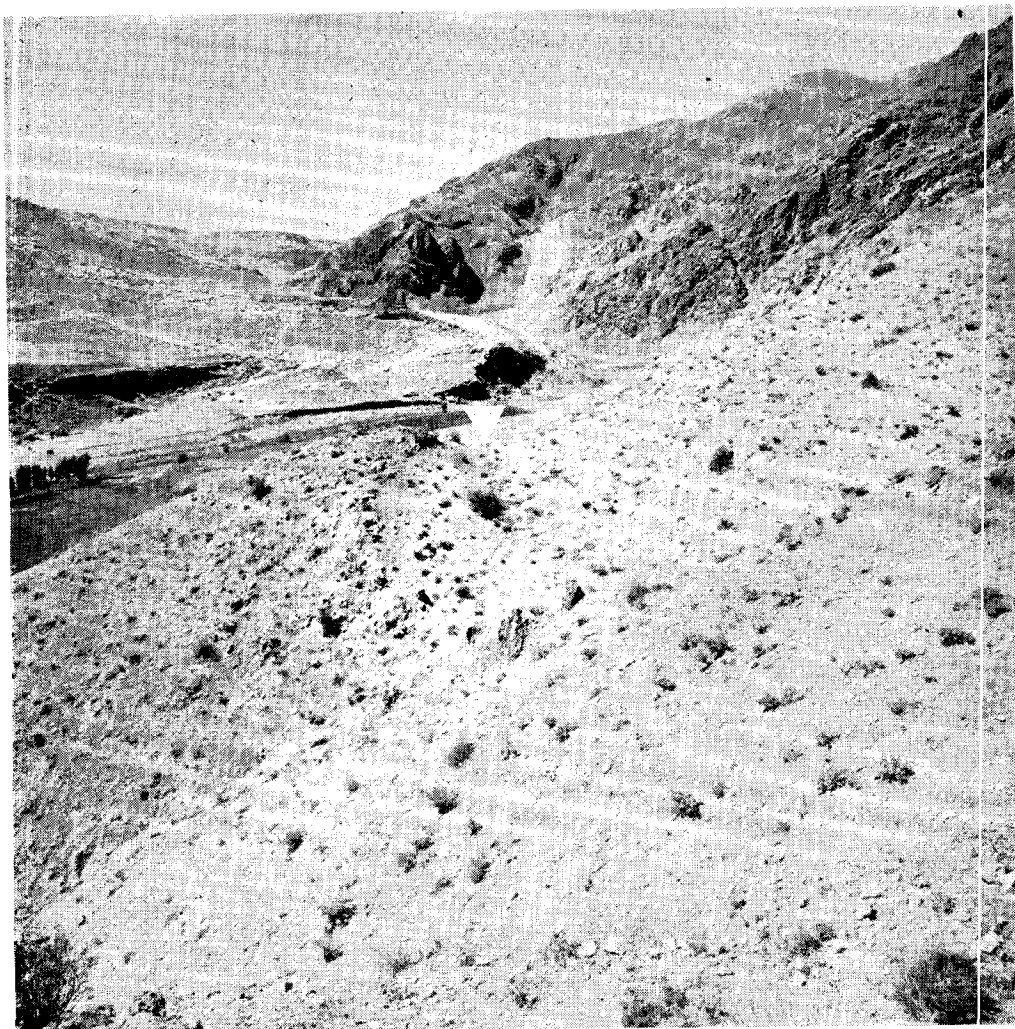
Fig. 52. Derik Fault. The earthquake fault trace (white triangle) stops before reaching the river, but earthquake fractures were found in an offset alinement in travertine further upstream (see Fig. 50).

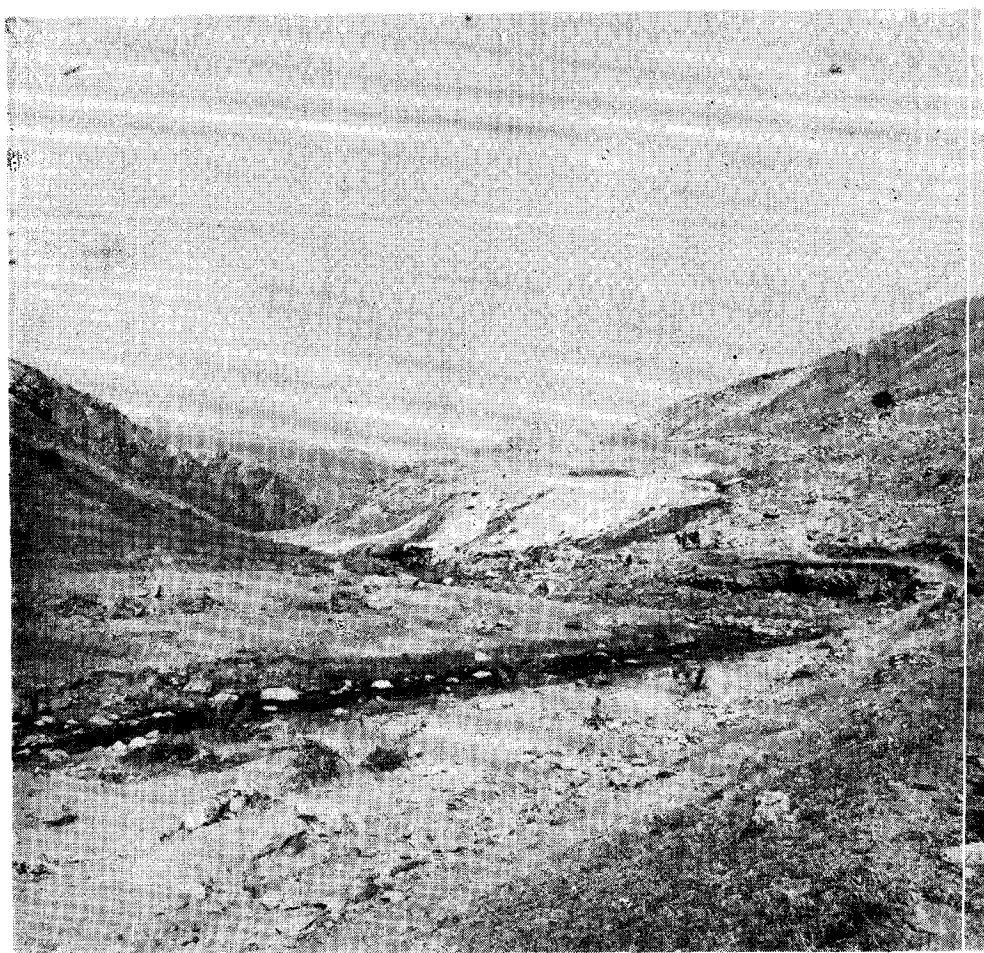
Fig. 54. Derik thermal springs. The white travertine outcrop in the mid-background was deposited after the earthquake by the main new spring.

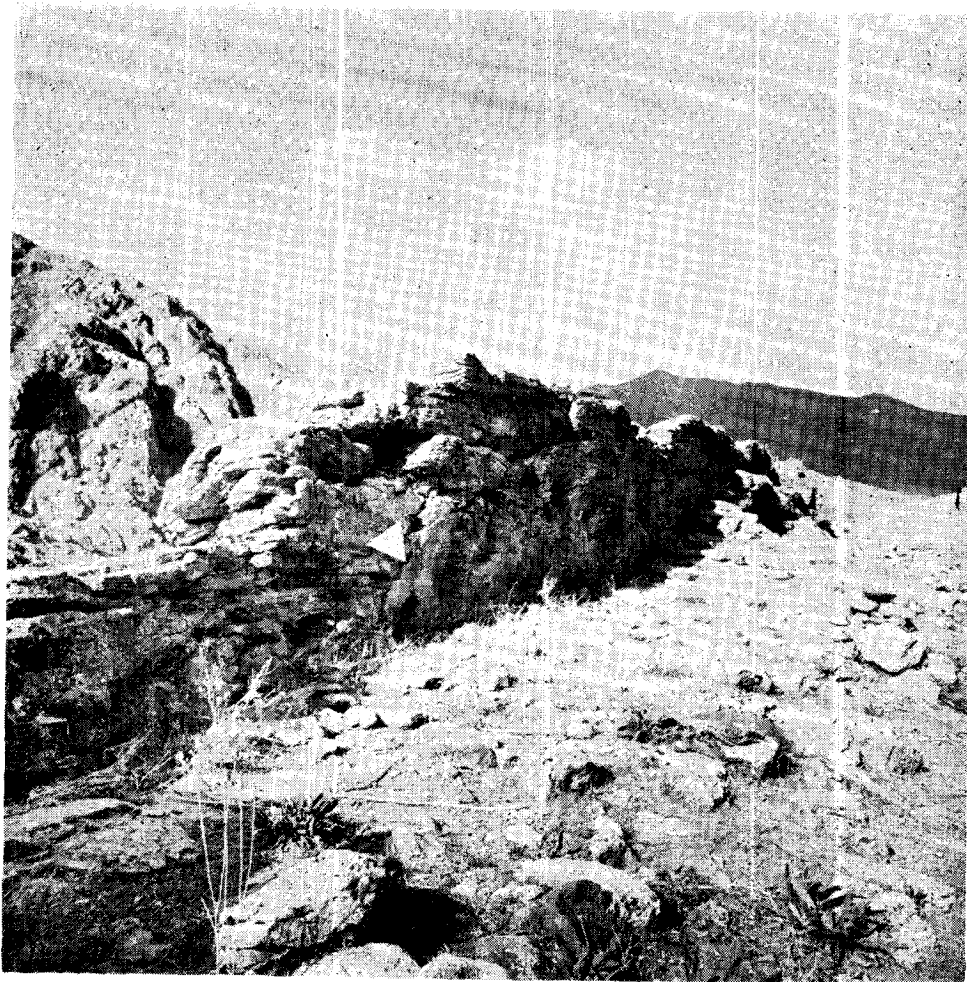
Fig. 55. Derik thermal springs. Older travertine dykes show a thin zone of vertical layering (white triangle) transecting the surrounding horizontal layering.
